Corwen Central News

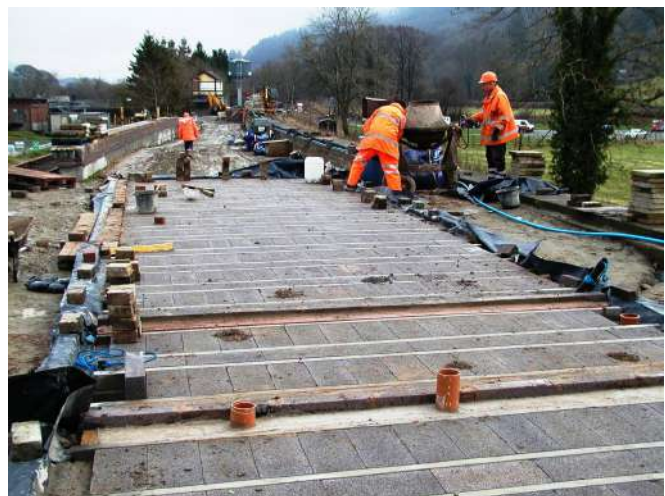
The floor of the new platform waiting room has been completed with the laying of the block and beam floor. Having built this building up to platform edge level, to allow for the placing of the

Block and beam waiting room floor nearing completion Photo: PR

paving blocks, the work will now be closed down whilst attention is turned to completion of the UP platform wall.

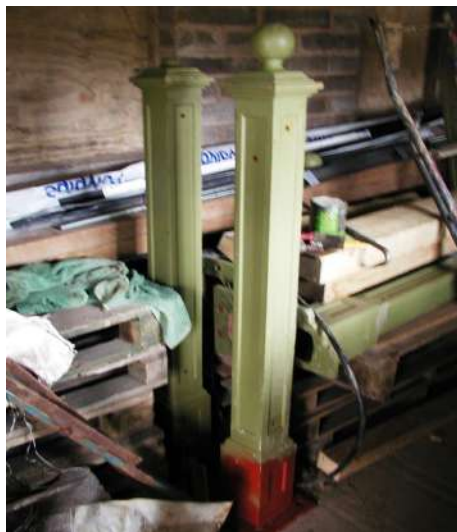
Burnham corner post Photo : PR

Volunteers, led by Tony Warren have been steadily bringing this tired fencing back to life to include removal of the old paint, repairing some of the hoops and breaking off the old concrete from the bases of the corner posts. It was whilst engaged in the latter job that Tony Warren found a 2016 weekly ticket. It fell out of the post when the concrete was broken off. How it had managed to get in there is a mystery as the fence in Burnham dates from the 1980s.

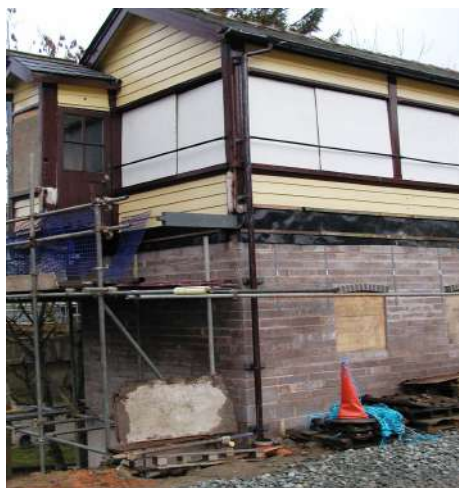
Guttering and down pipes on the signal box Photo : PR

weather, which in its turn allowed for suitable water proofing to be carried out. In recent weeks, Peter Neve has completed the job by adding roof gutters and down pipes to carry rainwater away from the structure. In the locking room a temporary wood working shop has been established so material can be prepared for further restoration work on the signal box and on other parts of the work area.

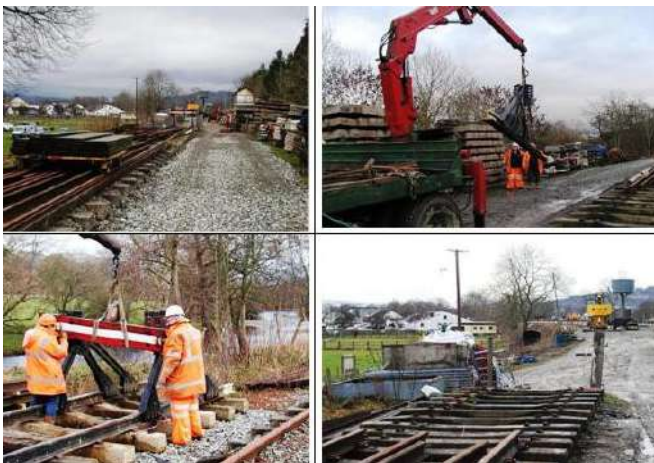
(Clock wise) Buffer stop on main line, Buffer frame on its way to new position, Buffer board being added to frame, Open end looking west
 Photos : PR

Corwen East Station ballast is being added to facilitate the accommodation of the UP siding and allow for a slight realignment of the main line so that the two sections can be joined together. This work will be completed once the buffer stops have been removed from the main line and put on sleepers on the new ballast. Photographs show the

removal and replacement of the main line buffer stop by a team lead by Paul Whitton.

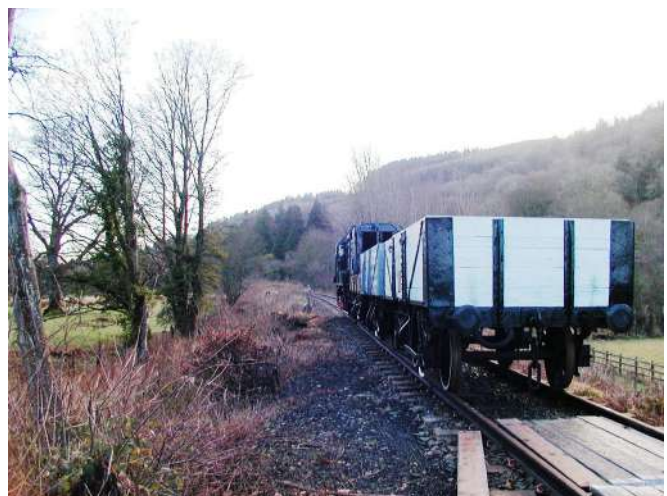
Class 08 Diesel Shunter and wagons arrive at Corwen East
 Photo : PR

The train consisted of three open wagons in charge of the 08 shunter, driven by Paul Reynolds and Robin Matthews. The wagons were dropped-off at the east end of the platform scaffold, where they will used to pick up the recovered wooden decking and other materials relevant to the dismantling of the platform.

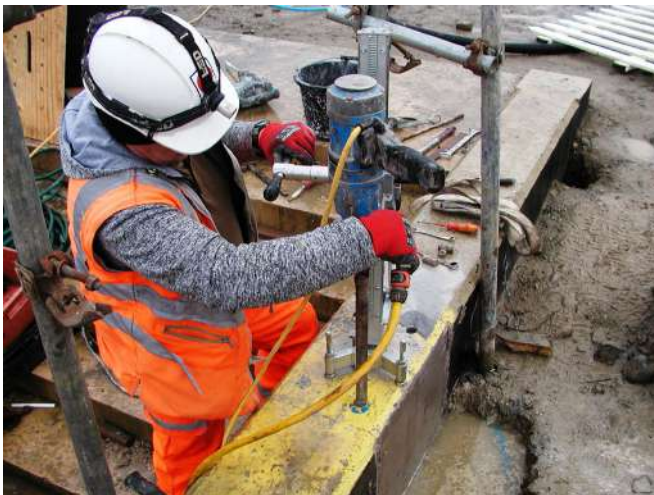
Third hole being drilled for saddle top Photo : PR

The accompanying photographs show the saddles and the coring drill with water cooled drill bit preparing the first holes. Note that the drill jig is held in place by a clamp attached to a threaded sleeve inserted into the concrete prior to the beginning of the main work.

As mentioned in a previous edition of CCNL a specialist company has been engaged to drill through the reinforced concrete at the top of the underpass to allow for the fixing of the canopy support columns. Overall 48 horizontal and vertical holes are required. Towards the end of January D-Drilling arrived on site to carry out the work. The drill is mounted on a precision jig so

depth and direction of the bore can be accurately controlled.

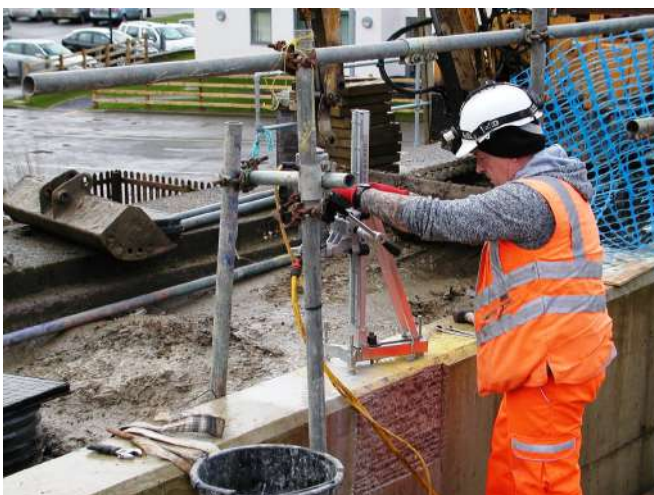
Drilling underway showing clamping bolt in centre of jig base Photo : PR
